NNC: The Reality of the Situation

Daniel Hammond
Senior Consultant

NNC: The *Biology* of the Situation

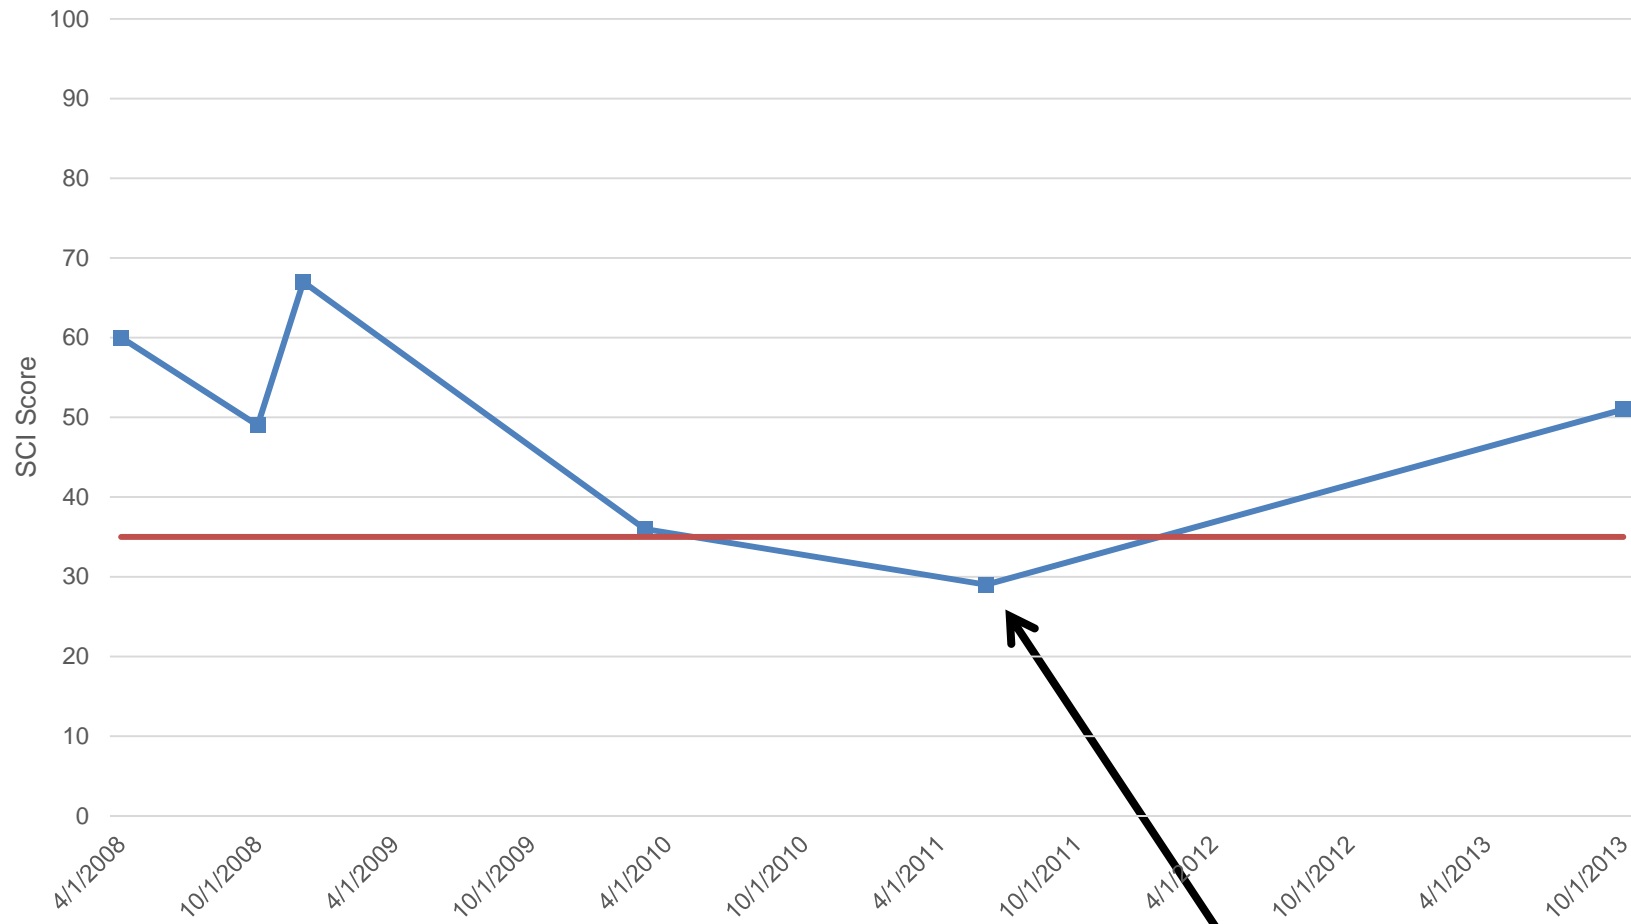
Stream below 7Q10
flow during sampling

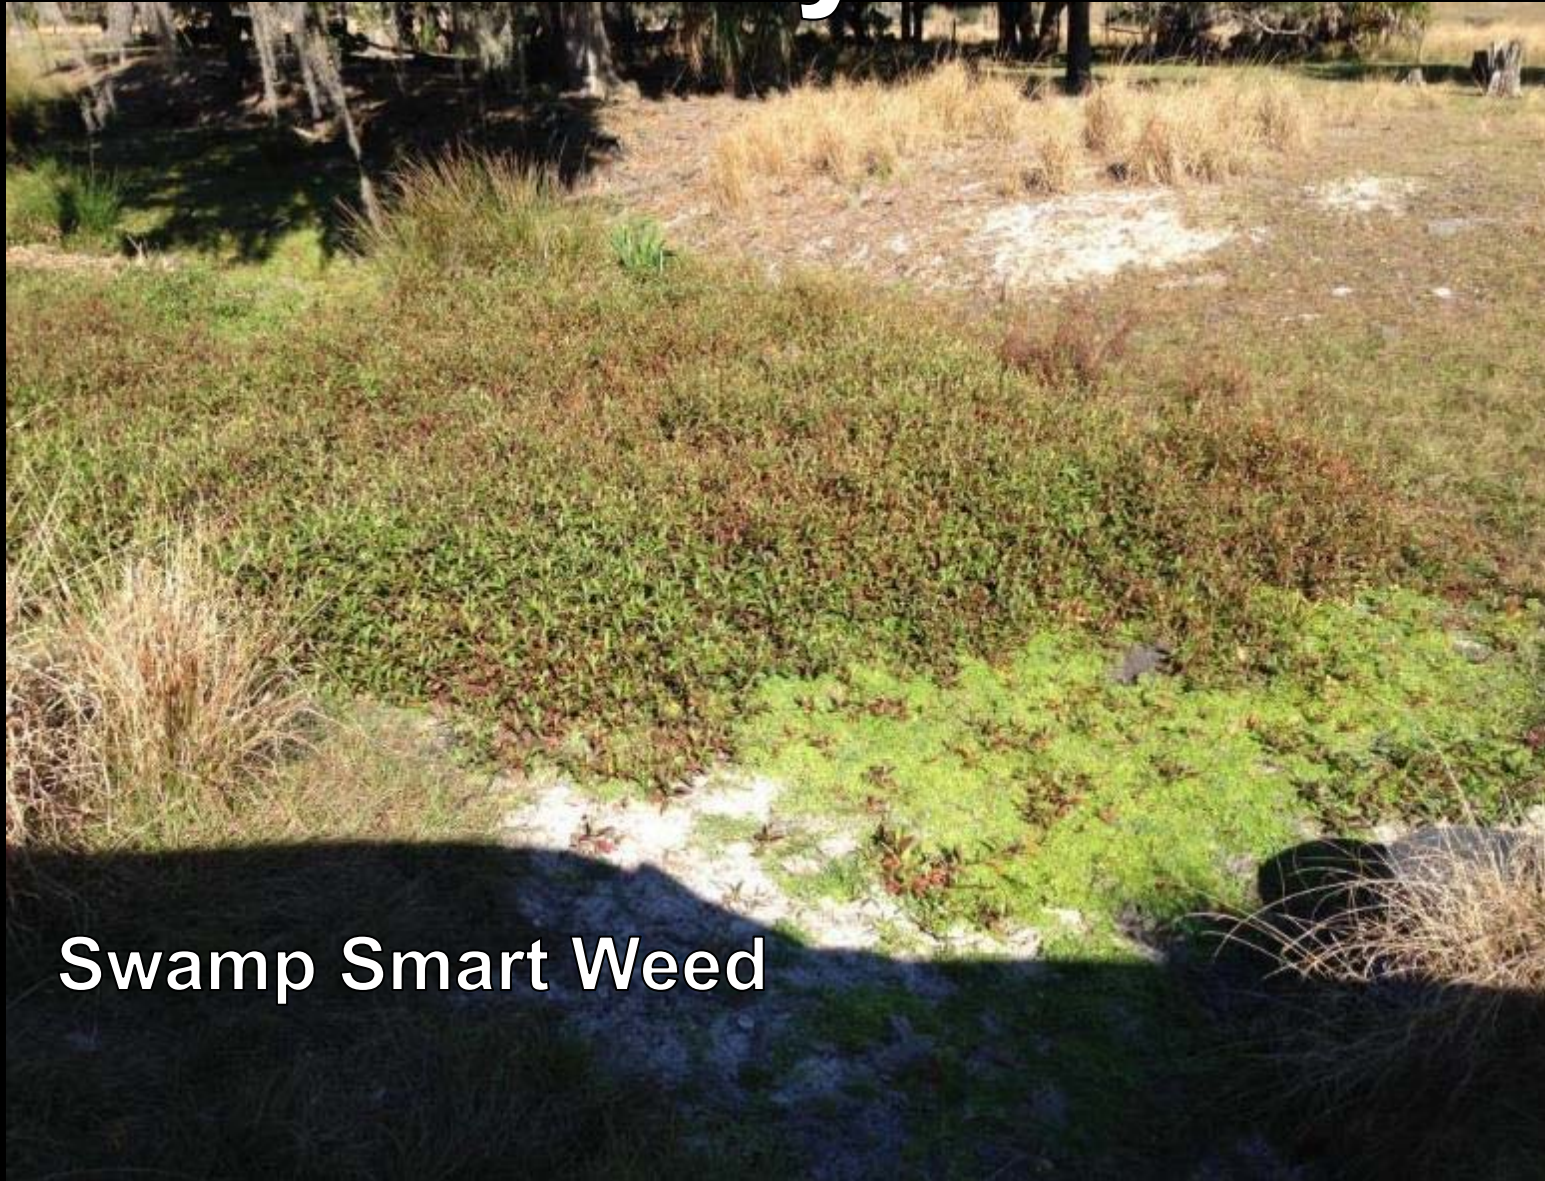
January 2014

Swamp Smart Weed

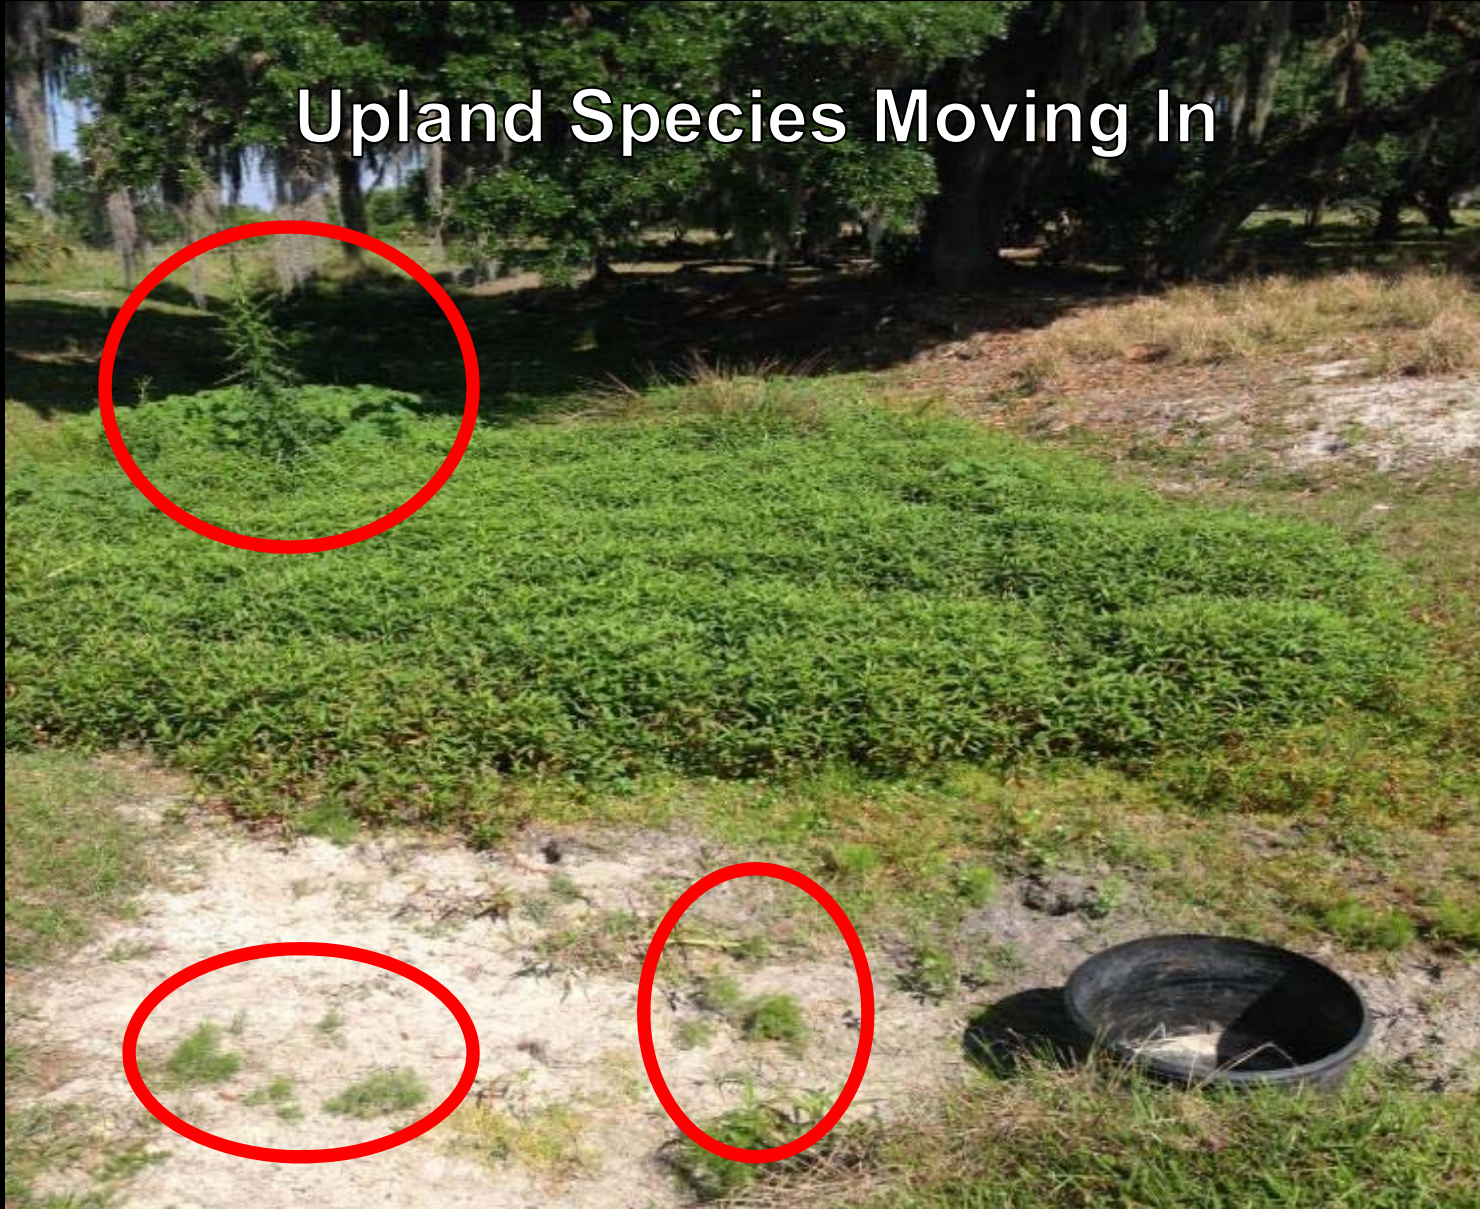
April 2014

Upland Species Moving In
